SEE HOW Tune-Rite™ FITS INTO YOUR COMBUSTION ANALYSIS PROCESS

Tune-Rite™ Provides...

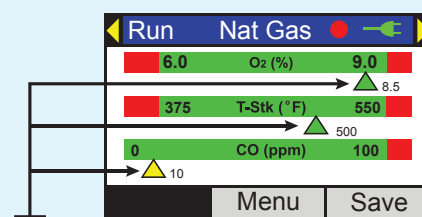
Watch the dynamic graph to see the combustion process reach steady-state.

- ▲ Red: Stable, outside range
- ▲ Yellow: Unstable
- ▲ Green: Stable, inside range

* If steady-state is not reached, combustion equipment may require major tuning, major repairs, or replacement.

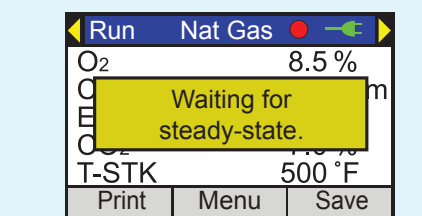
The dynamic graph, status dot, and status arrows confirm steady-state.

- Red: Not Ready
- Green: Ready

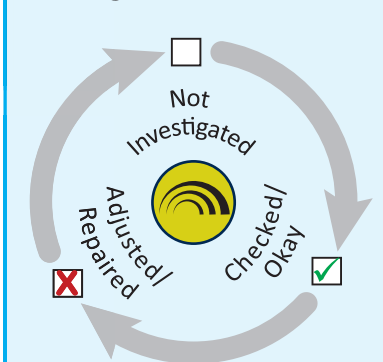
Track evaluation/repair progress of all possible causes using check boxes.

Cycle through options , , and using the enter button.

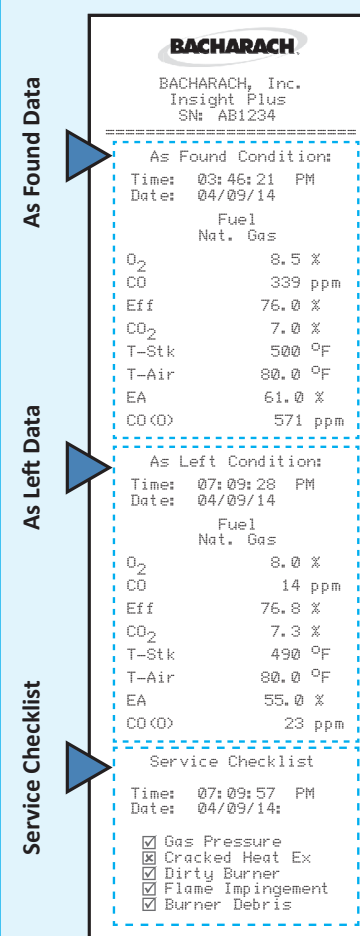
Review all readings in relation to typical operating ranges. One sample (CO reading) is shown below.

RESULT A: Inside Range

Combustion system is tuned (problems resolved/readings in range).

RESULT B: Outside Range

Combustion system is unable to reach typical operating ranges. Possible causes are still shown. Combustion equipment is likely to require major repairs or replacement.
